Project Profile:

Assessment of Potential Environmental Liabilities & Remediation Costs with Ground Investigation & Groundwater Risk Assessment

Former Site Use: Manufacturing Site Landfill

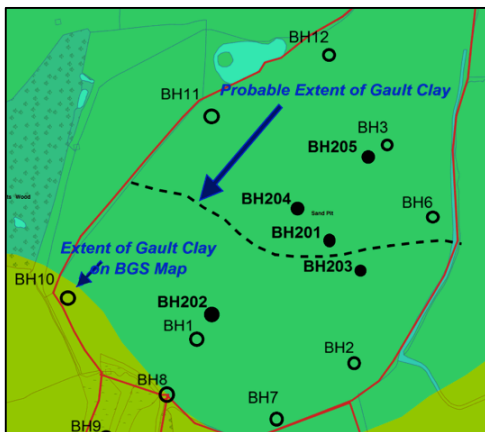
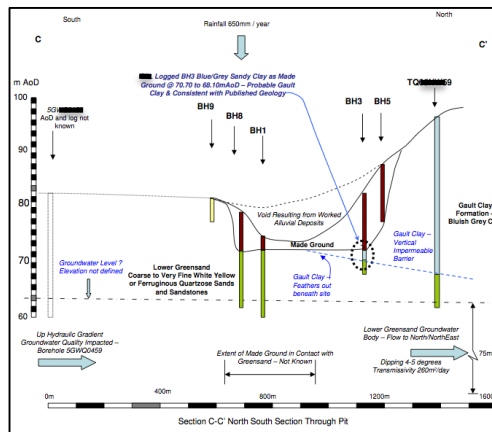
We implemented further ground investigation to disprove the earlier soil descriptions, obtain undisturbed samples of basal clay for permeability testing and install groundwater sampling wells with separate and discrete response zones in the both waste and underlying aquifer. We conducted rising head permeability testing; and carried out a reduced level survey to determine gradient.
