Project Profile:

Assessment of Potential Environmental Liabilities & Remediation Costs with Ground Investigation & Groundwater Risk Assessment

Former Site Use: Manufacturing Site Landfill

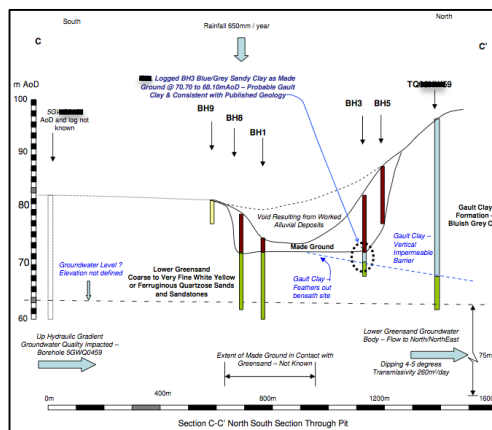
We implemented further ground investigation to disprove the earlier soil descriptions, obtain undisturbed samples of basal clay for permeability testing and install groundwater sampling wells with separate and discrete response zones in the both waste and underlying aquifer. We conducted rising head permeability testing; and carried out a reduced level survey to determine gradient.
